## **The Tyron R4**

## ALL TERRAIN RUNFLAT (ATR) (Patent Pending)

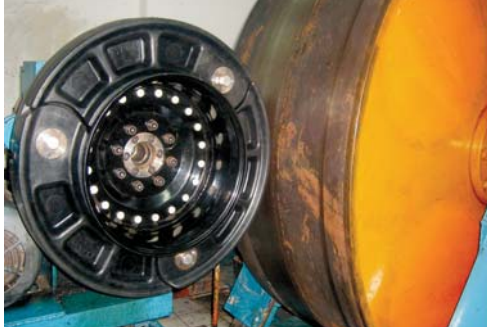
Setting up Tyron ATR for testing on a rolling road

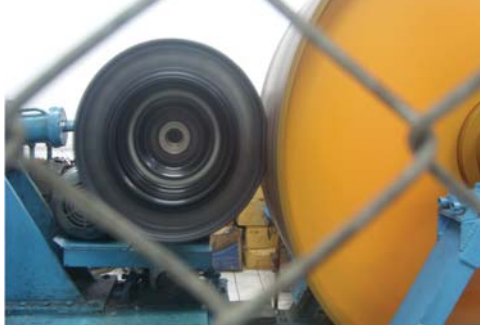
Tyron ATR undergoing load and speed testing

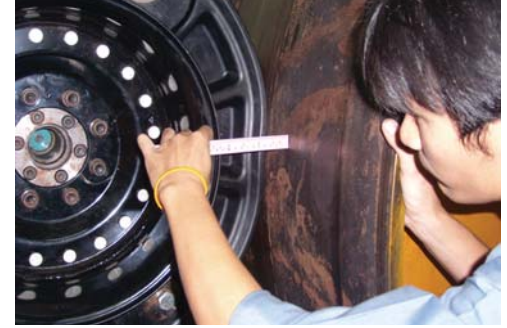
Measuring unique load deflection characteristics

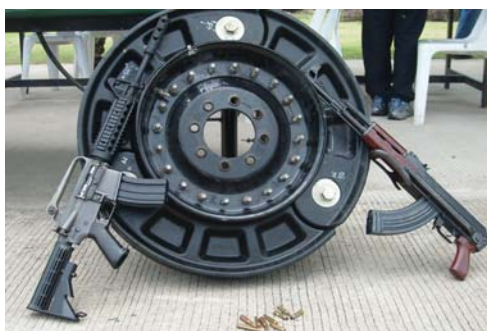
High powered assault rifles

First test was carried out to the Finabel standard, but without the tire fitted. 5 shots into the side of the runflat and 2 into the tread area from 50 meters with an AK47 using 7.62mm bullets and an M16 using 5.56mm bullets.

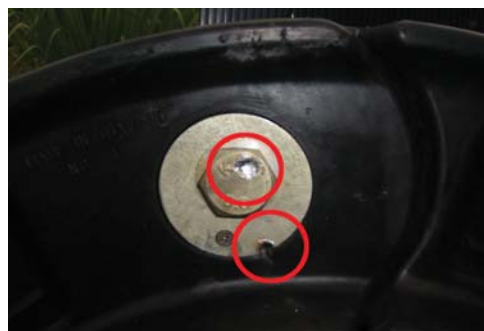
Minimum impact damage to runflat fixings

Special effort was made to hit the fixings with one bullet making a direct hit on the fixing head which ricocheted off and another hitting the washer and was absorbed. The

other three simply passed through the rubber system. The two shots into the tread area around the fixings were simply absorbed therefore none of the shooting had any effect on the performance of the runflat system.

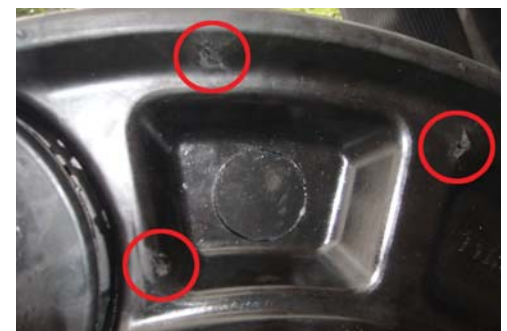
Impact is easily absorbed with no structural breakdown

Even without the added protection of the tire, a total of 35 direct hits on the runflat all aimed at and around the fixings were simply absorbed.
